Renovation Specific Bulk Asbestos Survey Report

**908 US 50
Pueblo, CO 81008**

**Anderson Property Inspections
Colorado Springs, CO**

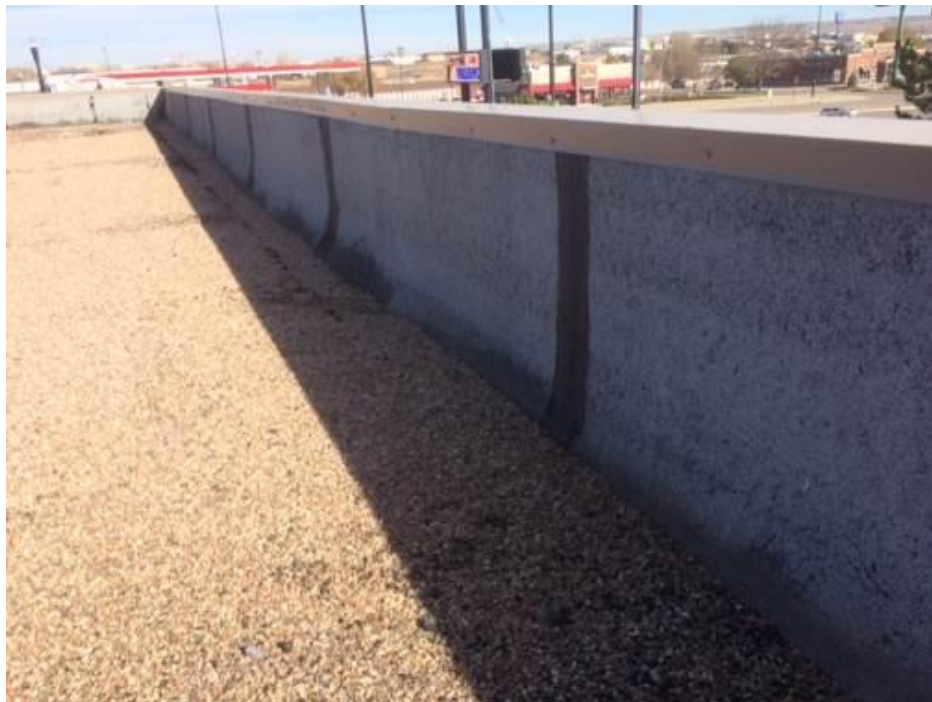
Tar and gravel base material and rolled roofing on parapet walls both tested non-detect for asbestos

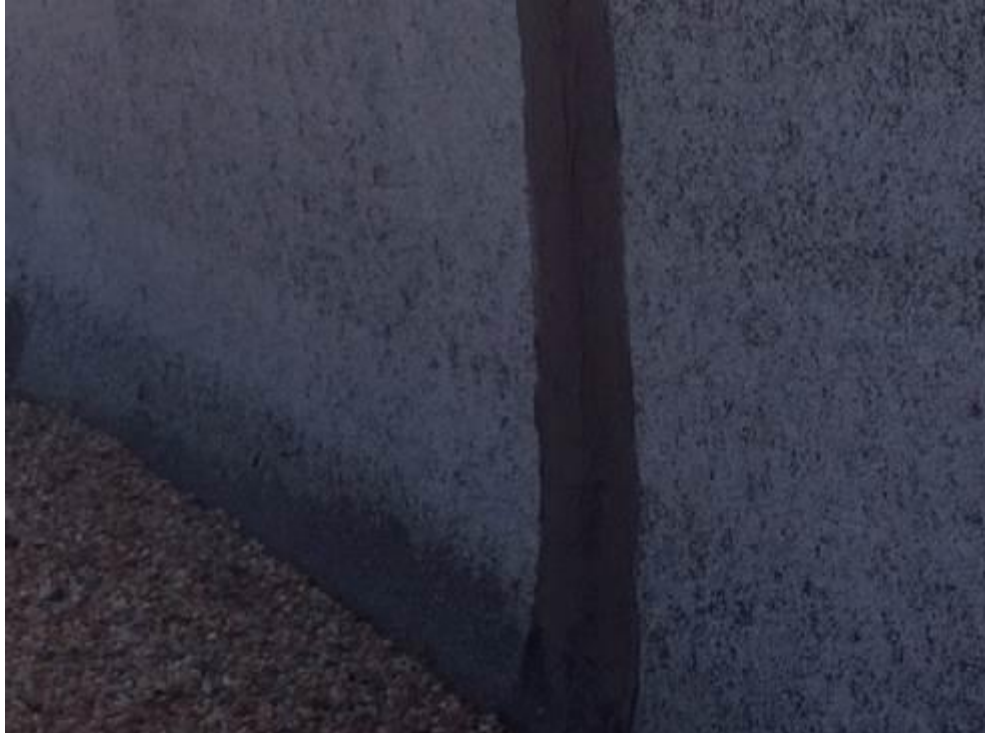
Roofing tar used on seams tested non-detect

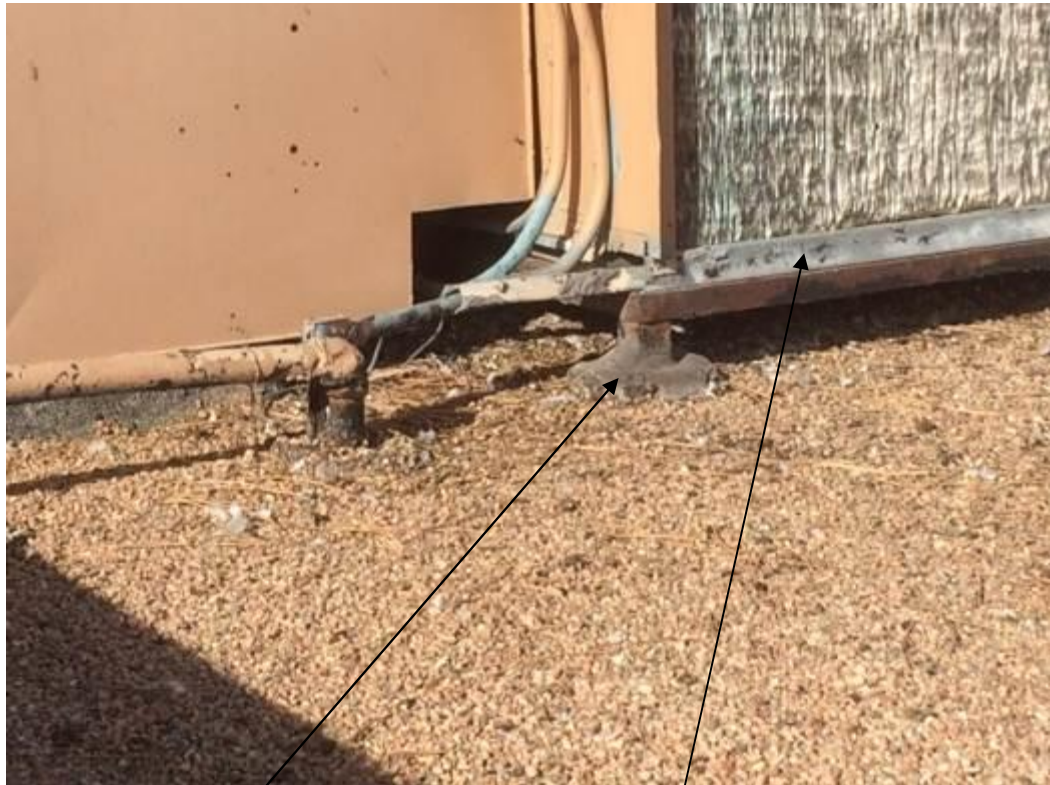
Tar on HVAC unit supports and associated gray sealant both tested non-detect for asbestos

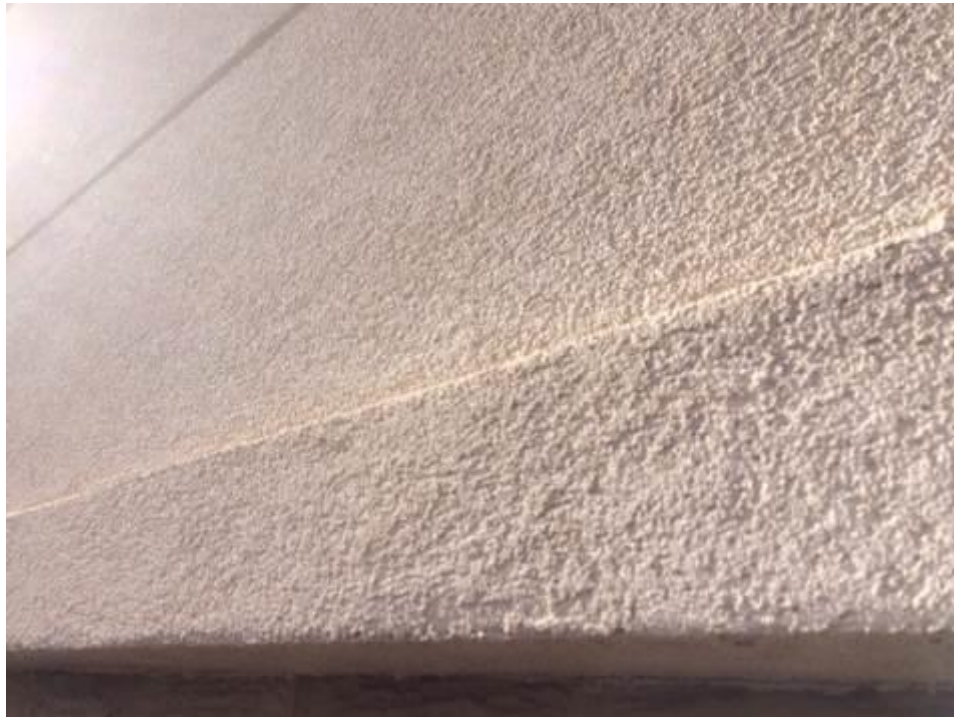
Stucco plaster on eastern elevation tested non-detect

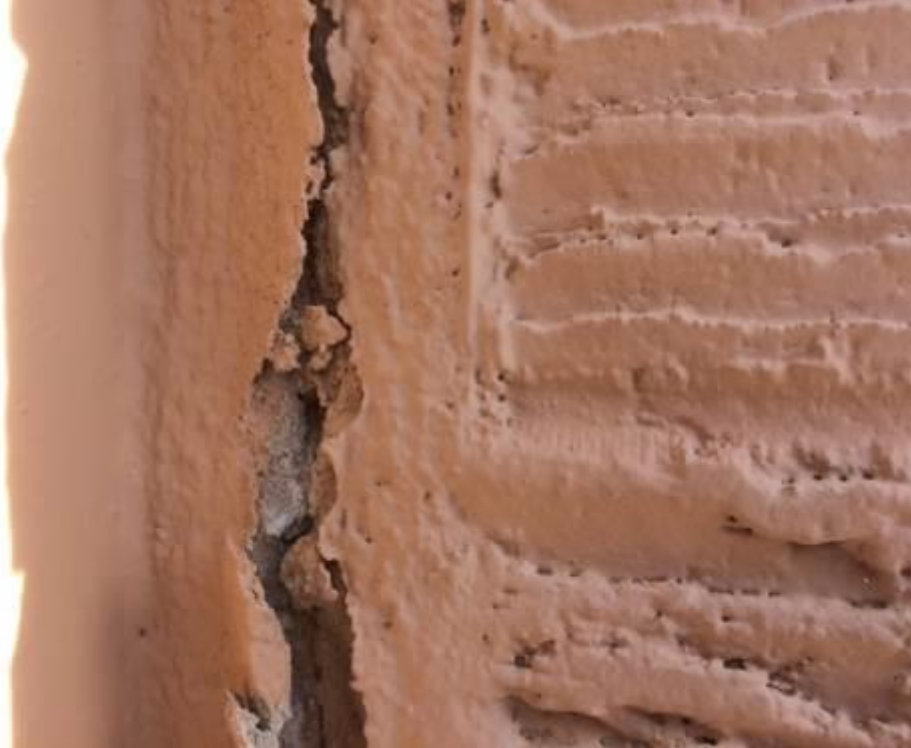
Brick façade mortar on exterior tested non-detect

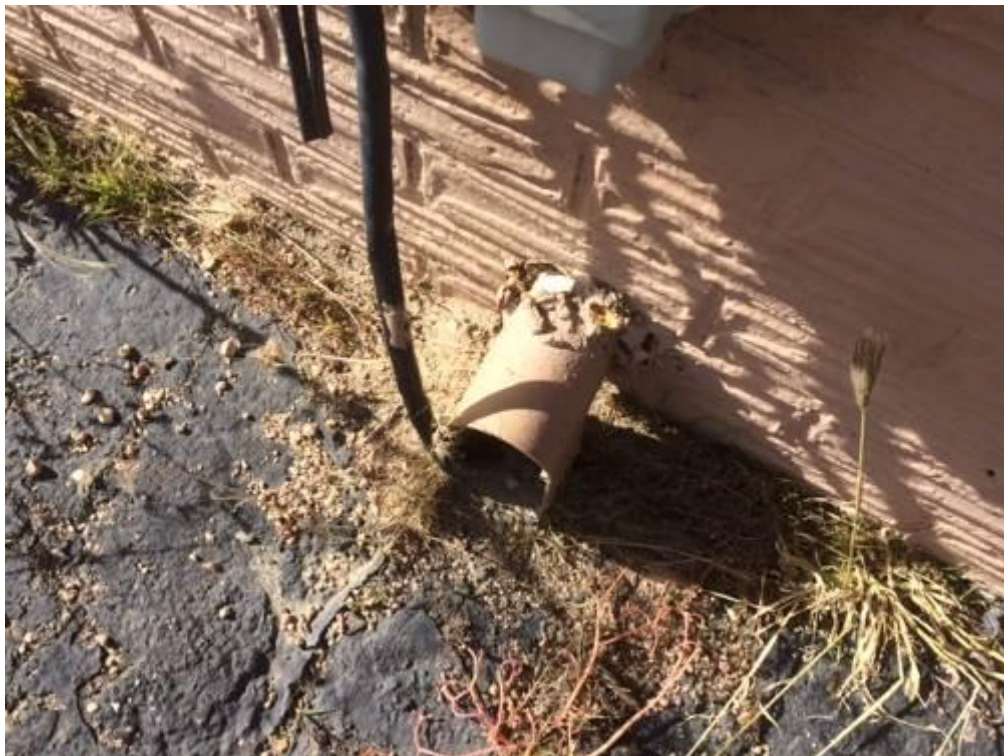
Conduit and drain sealant on eastern elevation tested non-detect
