**US 50 WEST WESTBOUND
 BNSF RR BRIDGE REPAIRS
 FRAMING PLAN**

Project No./Code	STA 0503-085
	20344
Sheet Number	136

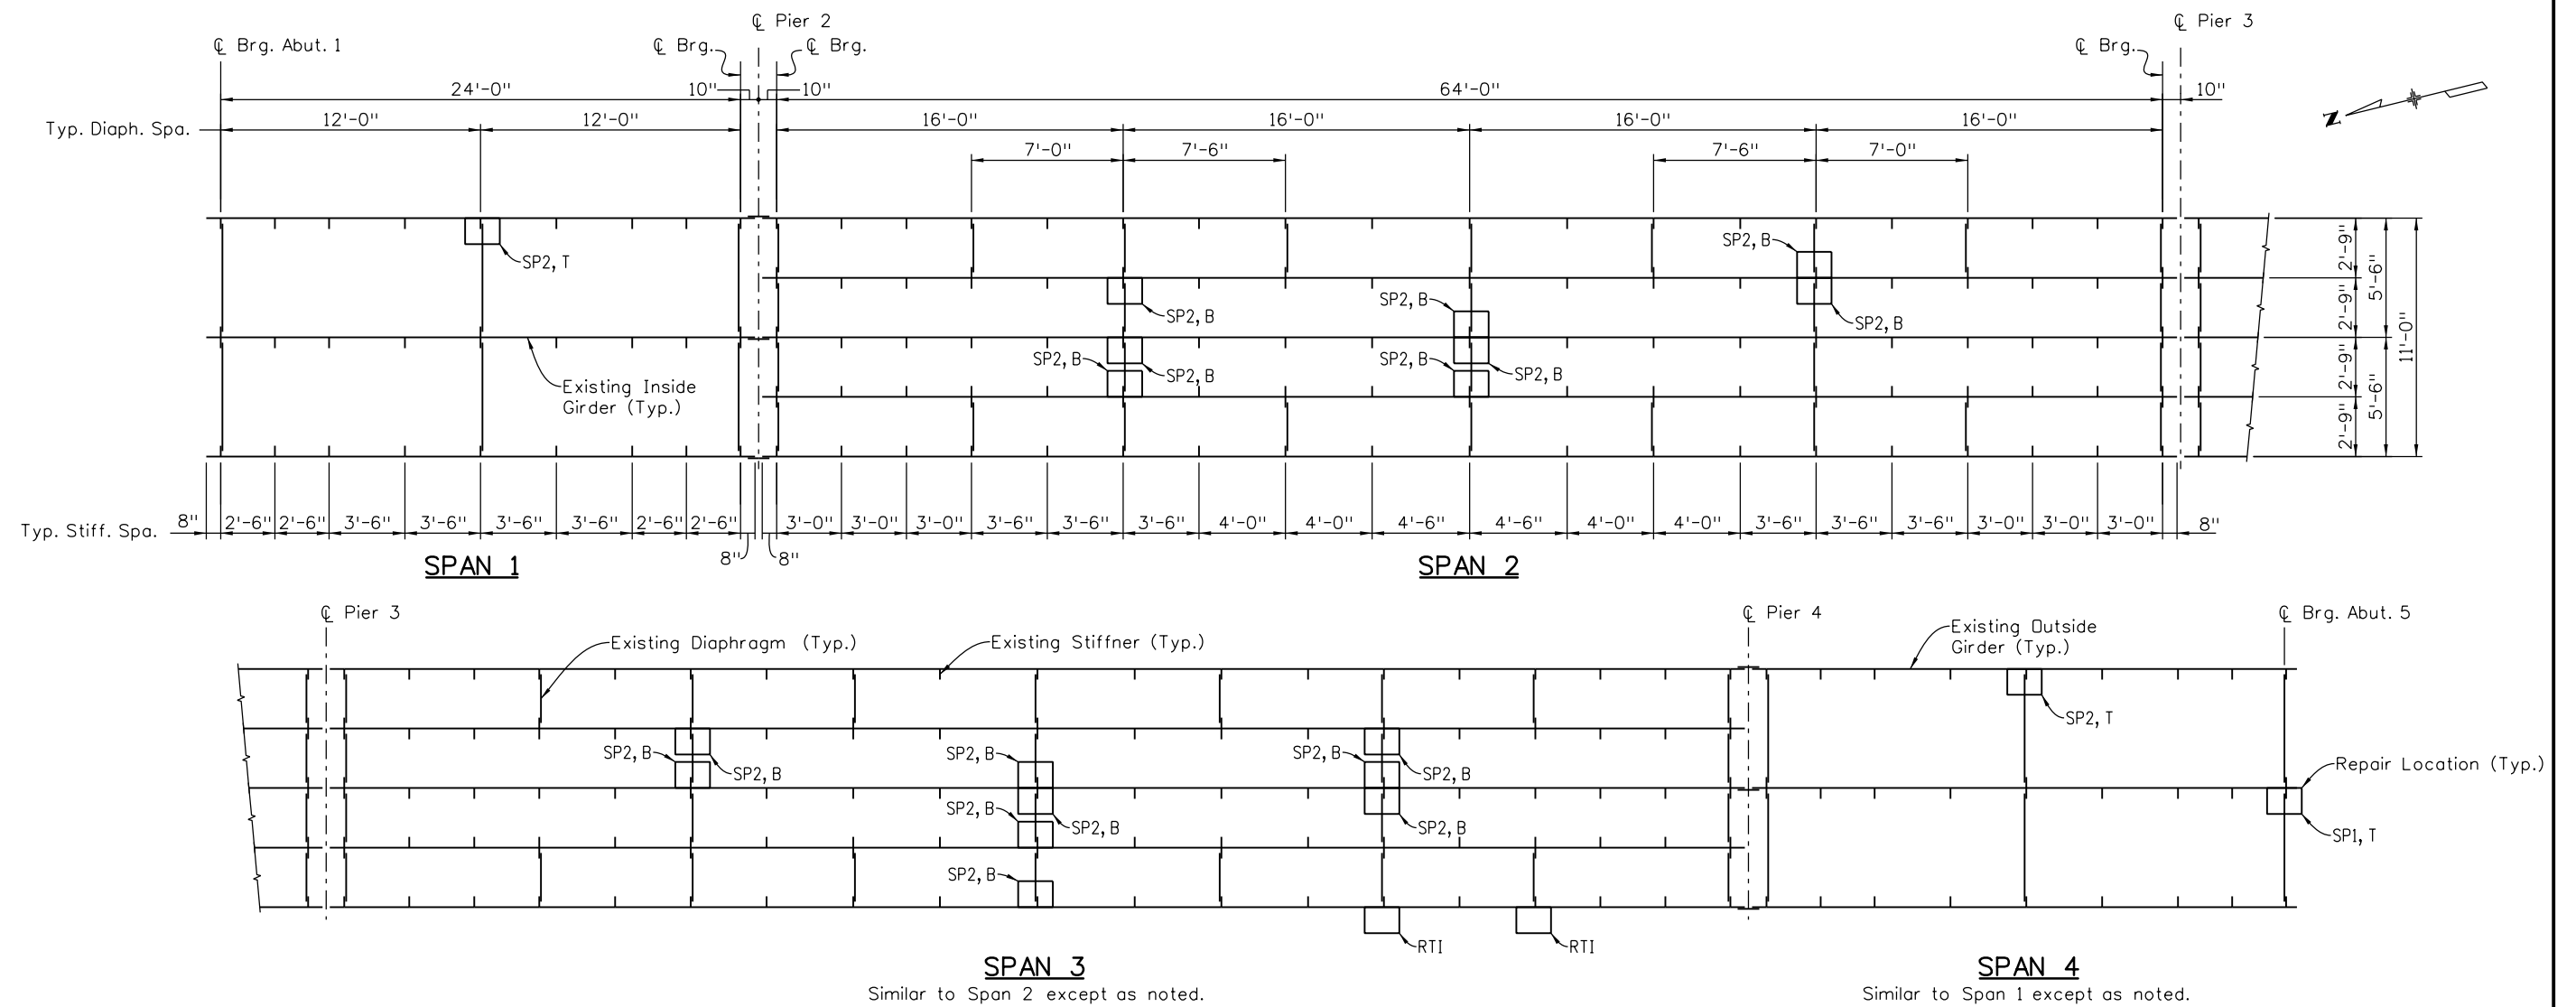
FRAMING PLAN

- SP1: Shear Plate 1 Detail
- SP2: Shear Plate 2 Detail
- T: Crack at top of diaphragm
- B: Crack at bottom of diaphragm
- RTI: Repair Type I only, located in web

3. Install Repair Type I and II at all locations noted SP1 or SP2. Repair Type I shall be complete before Repair Type II. See "Diaphragm Repairs" sheet.
