# Geotechnical Engineering Report

Candlewood Hotel  
Eagleridge Boulevard and Dillon Drive  
Pueblo, Colorado  
July 10, 2015  
Terracon Project Number: B8155021

**Prepared for:**  
Quest Construction, LLC  
Aberdeen, South Dakota

**Prepared by:**  
Terracon Consultants, Inc.  
Colorado Springs, Colorado

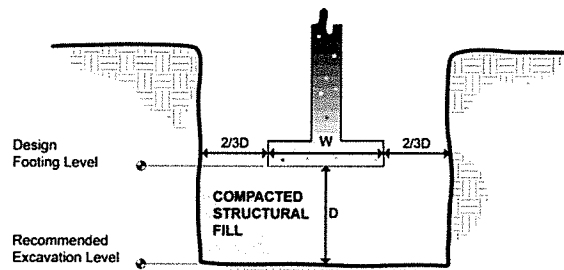
#### Overexcavation / Backfill

The base of all foundation excavations should be free of water and loose soil and rock prior to placing concrete. If unsuitable soils are encountered at the base of the over-excavation, supplemental recommendations will be required, such as additional removal and replacement. Over-excavation for compacted backfill placement below footings should extend laterally beyond all edges of the footings at least 8 inches per foot of overexcavation depth below footing base elevation.

NOTE: Excavations in sketches shown vertical for convenience. Excavations should be sloped as necessary for safety.

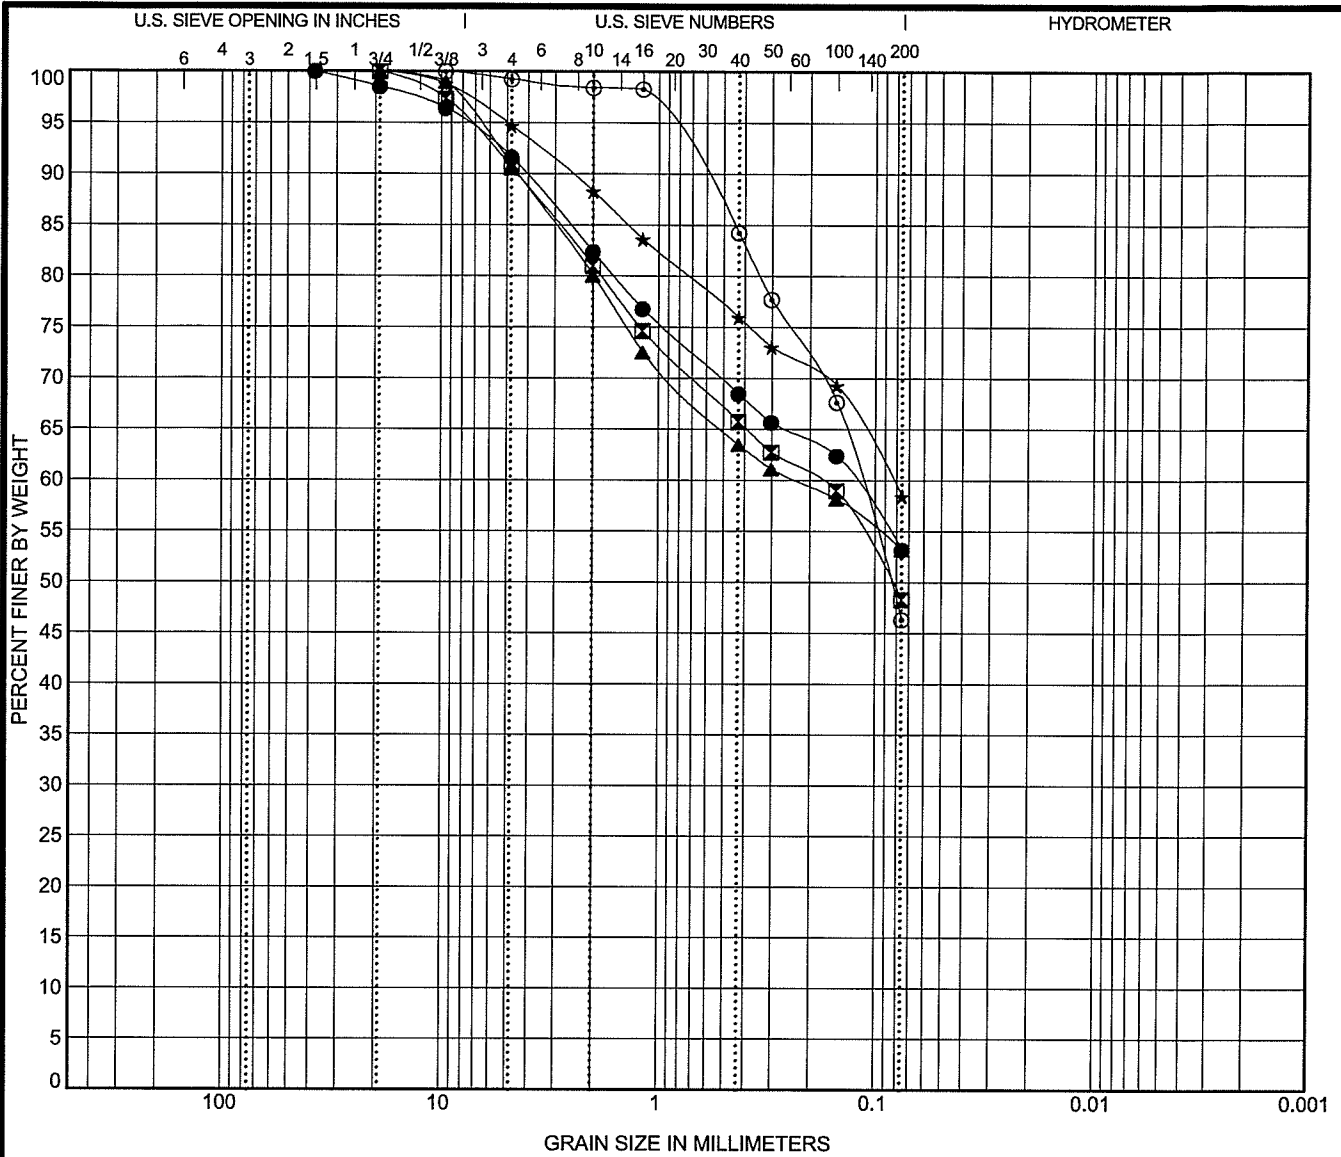
# GRAIN SIZE DISTRIBUTION

ASTM D422

Boring ID	Depth	USCS Classification				LL	PL	PI	Cc	Cu
● B-1	1 - 10	SANDY LEAN CLAY (CL)				33	18	15		
☒ B-1	2 - 3	CLAYEY SAND (SC)				36	17	19		
▲ B-2	4 - 5	SANDY LEAN CLAY (CL)				36	19	17		
★ B-3	4 - 5	SANDY LEAN CLAY (CL)				36	17	19		
⊙ B-4	7 - 8	WEATHERED CLAYEY SANDSTONE				37	17	20

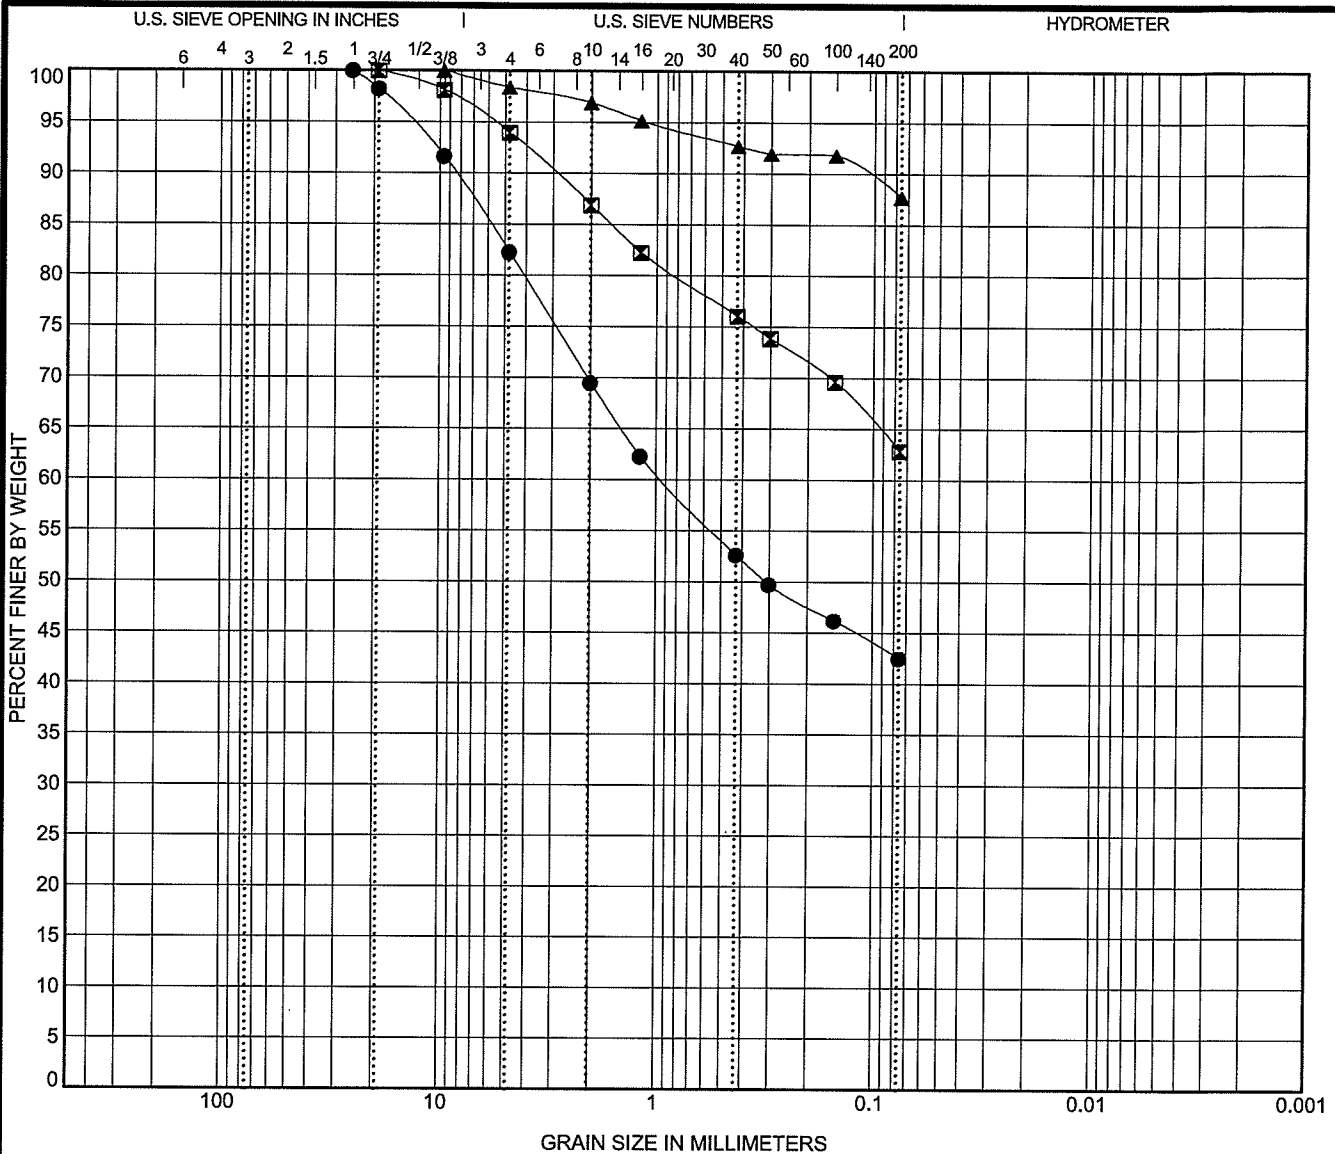
# GRAIN SIZE DISTRIBUTION

ASTM D422

Boring ID	Depth	USCS Classification	LL	PL	PI	Cc	Cu
● B-6	1 - 10	CLAYEY SAND with GRAVEL(SC)	29	16	13		
☒ B-7	0 - 1	SANDY LEAN CLAY(CL)	35	18	17		
▲ B-8	0 - 1	LEAN CLAY(CL)	40	20	20

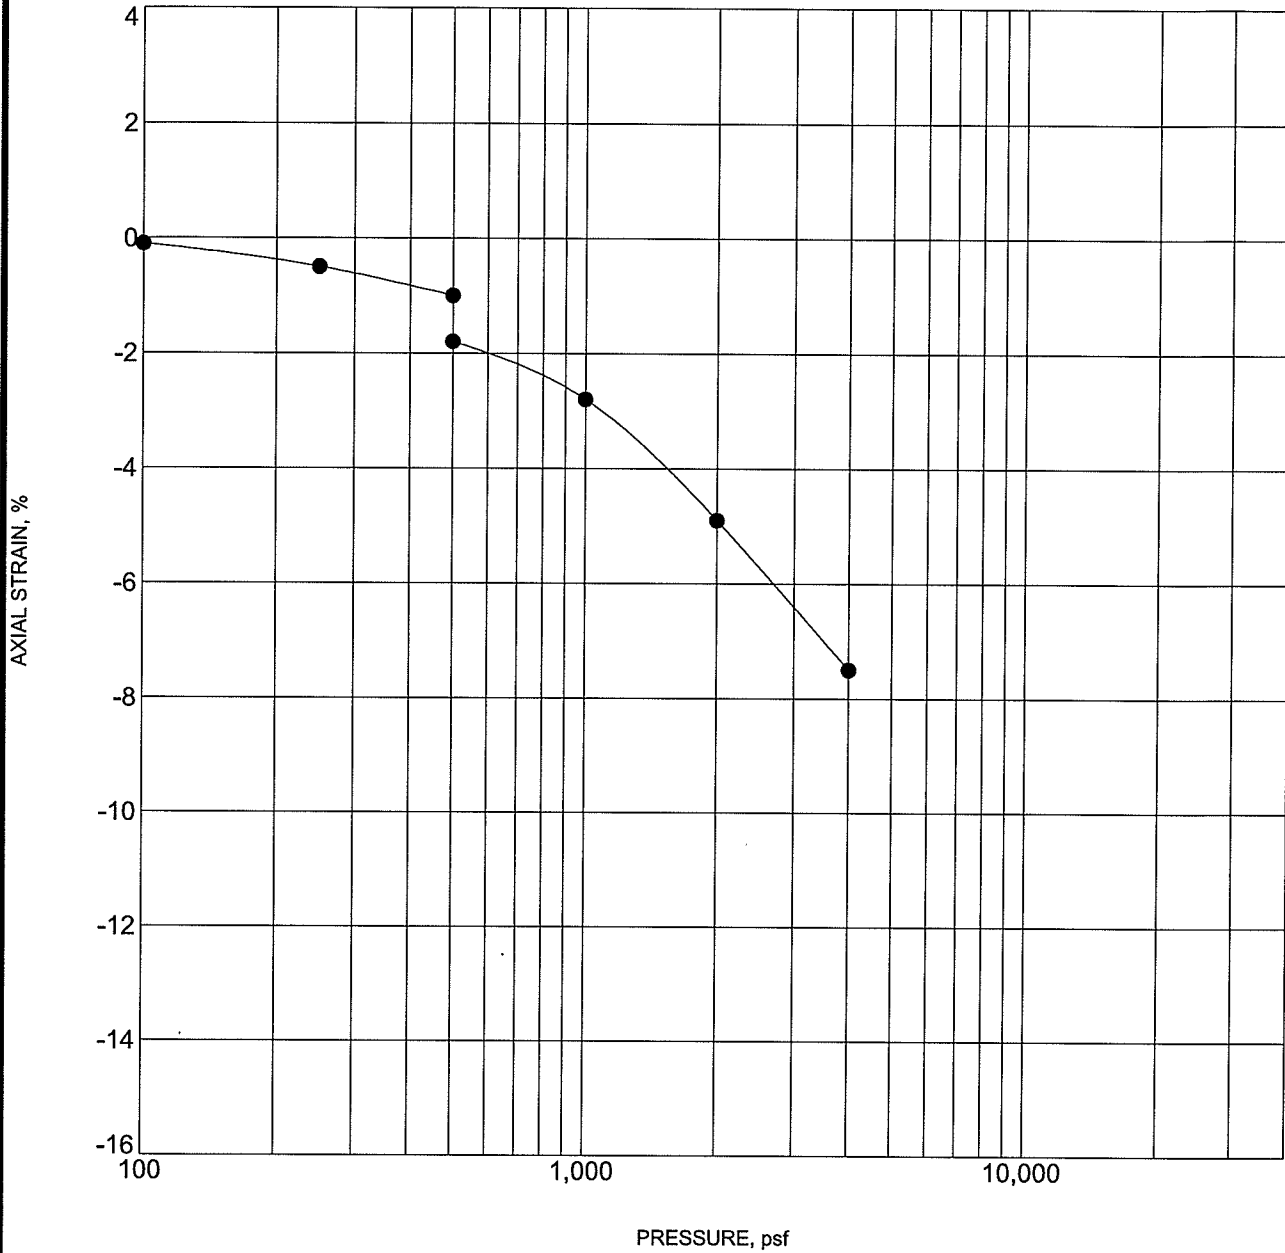
# SWELL CONSOLIDATION TEST

ASTM D4546

Specimen Identification	Classification	$\gamma_d$ , pcf	WC, %
● B-1      4 - 5 ft	FILL-CLAYEY SAND(SC)	107	7

NOTES: Sample inundated with water at 500 pounds per square foot (psf.)

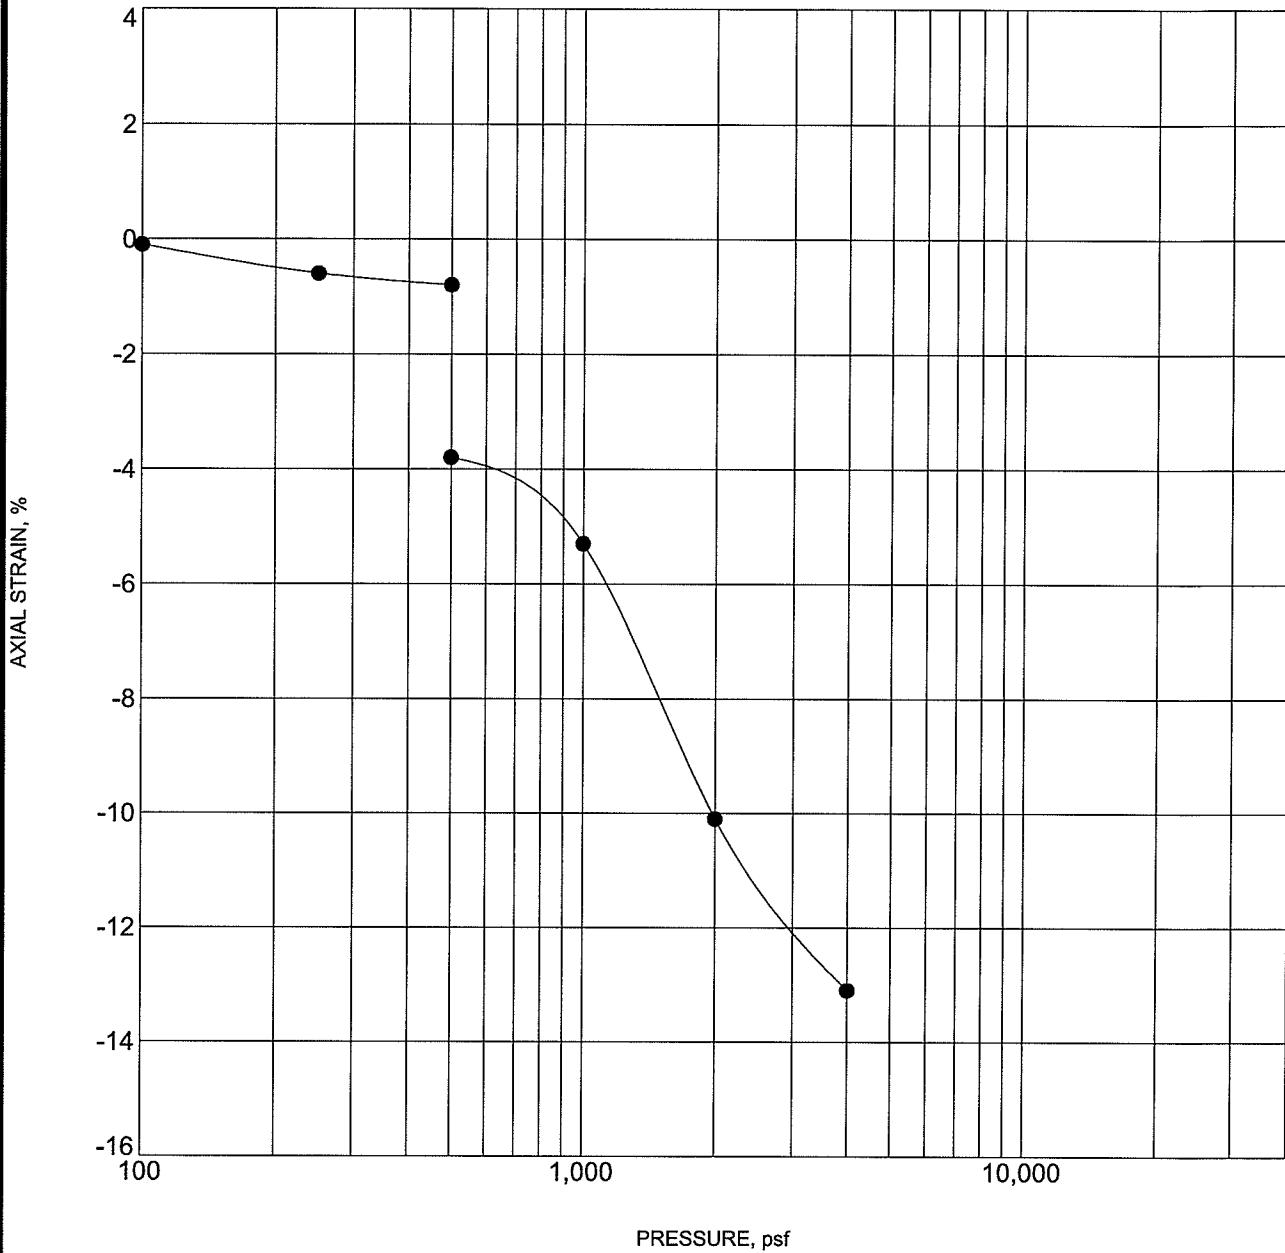
# SWELL CONSOLIDATION TEST

ASTM D4546

●	Specimen Identification	Classification	$\gamma_d$ , pcf	WC, %
	B-2      7 - 8 ft	FILL-SANDY LEAN CLAY(CL)	99	7

NOTES: Sample inundated with water at 500 pounds per square foot (psf.)

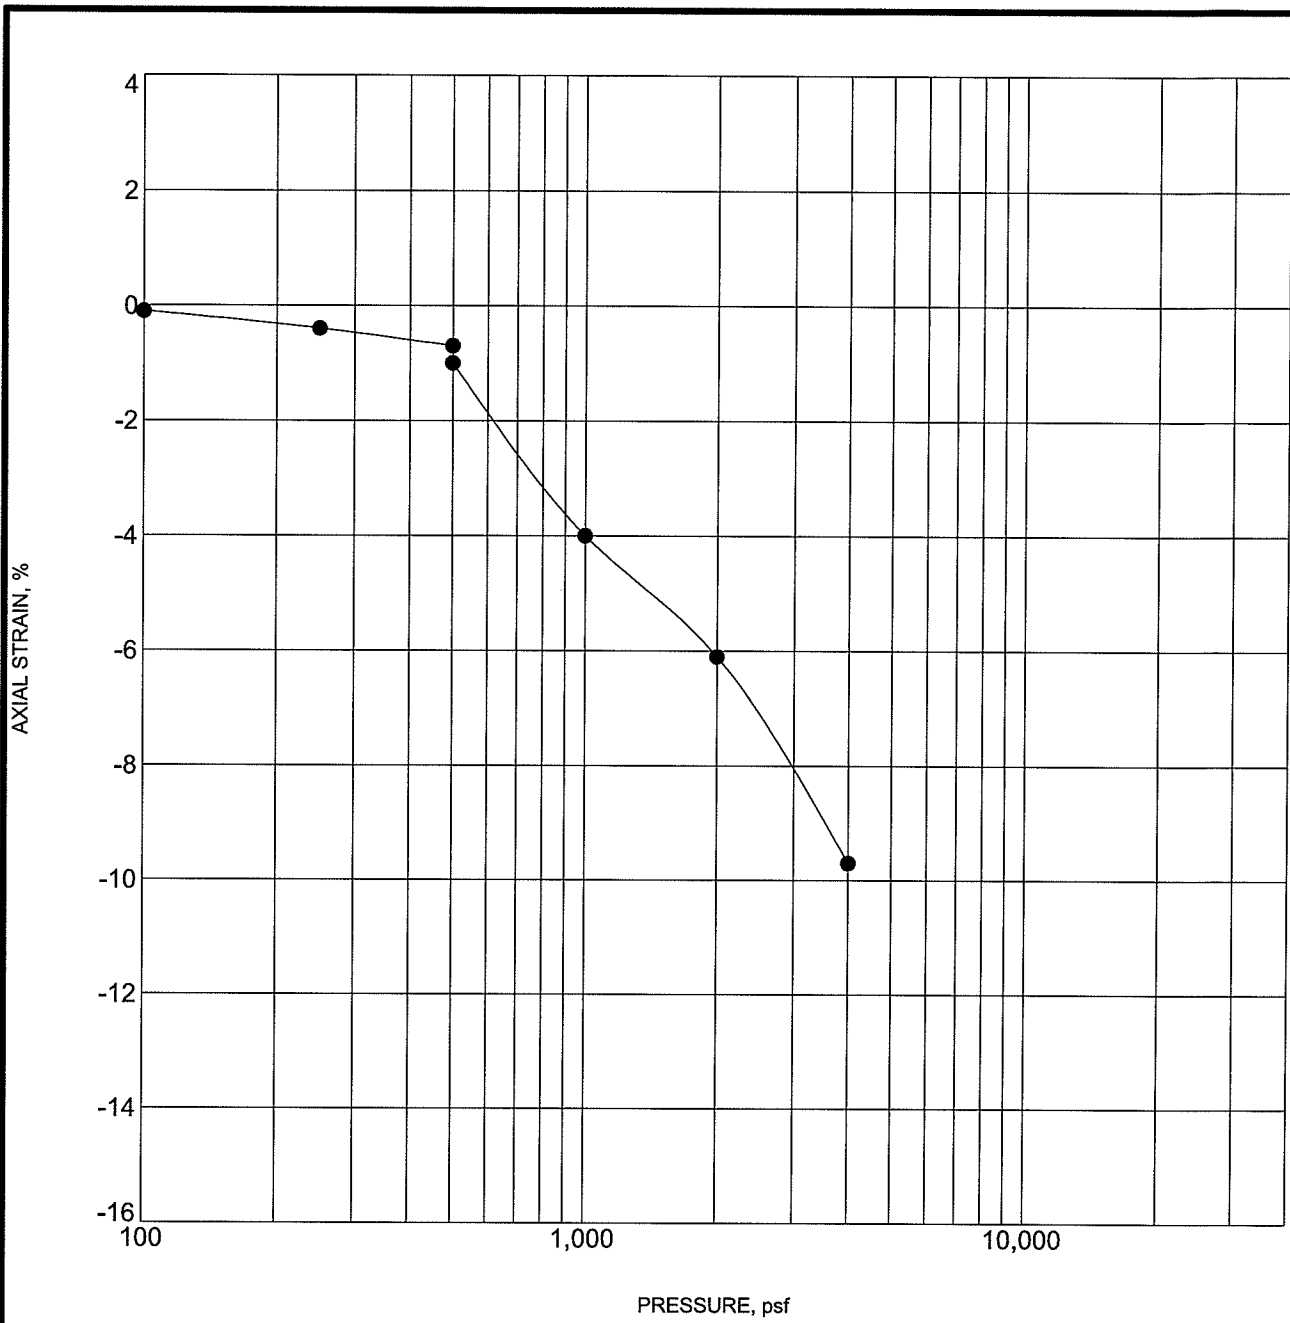
# SWELL CONSOLIDATION TEST

ASTM D4546

Specimen Identification	Classification	$\gamma_d$ , pcf	WC, %
● B-3      2 - 3 ft	FILL-SANDY LEAN CLAY(CL)	98	8

NOTES: Sample inundated with water at 500 pounds per square foot (psf.)

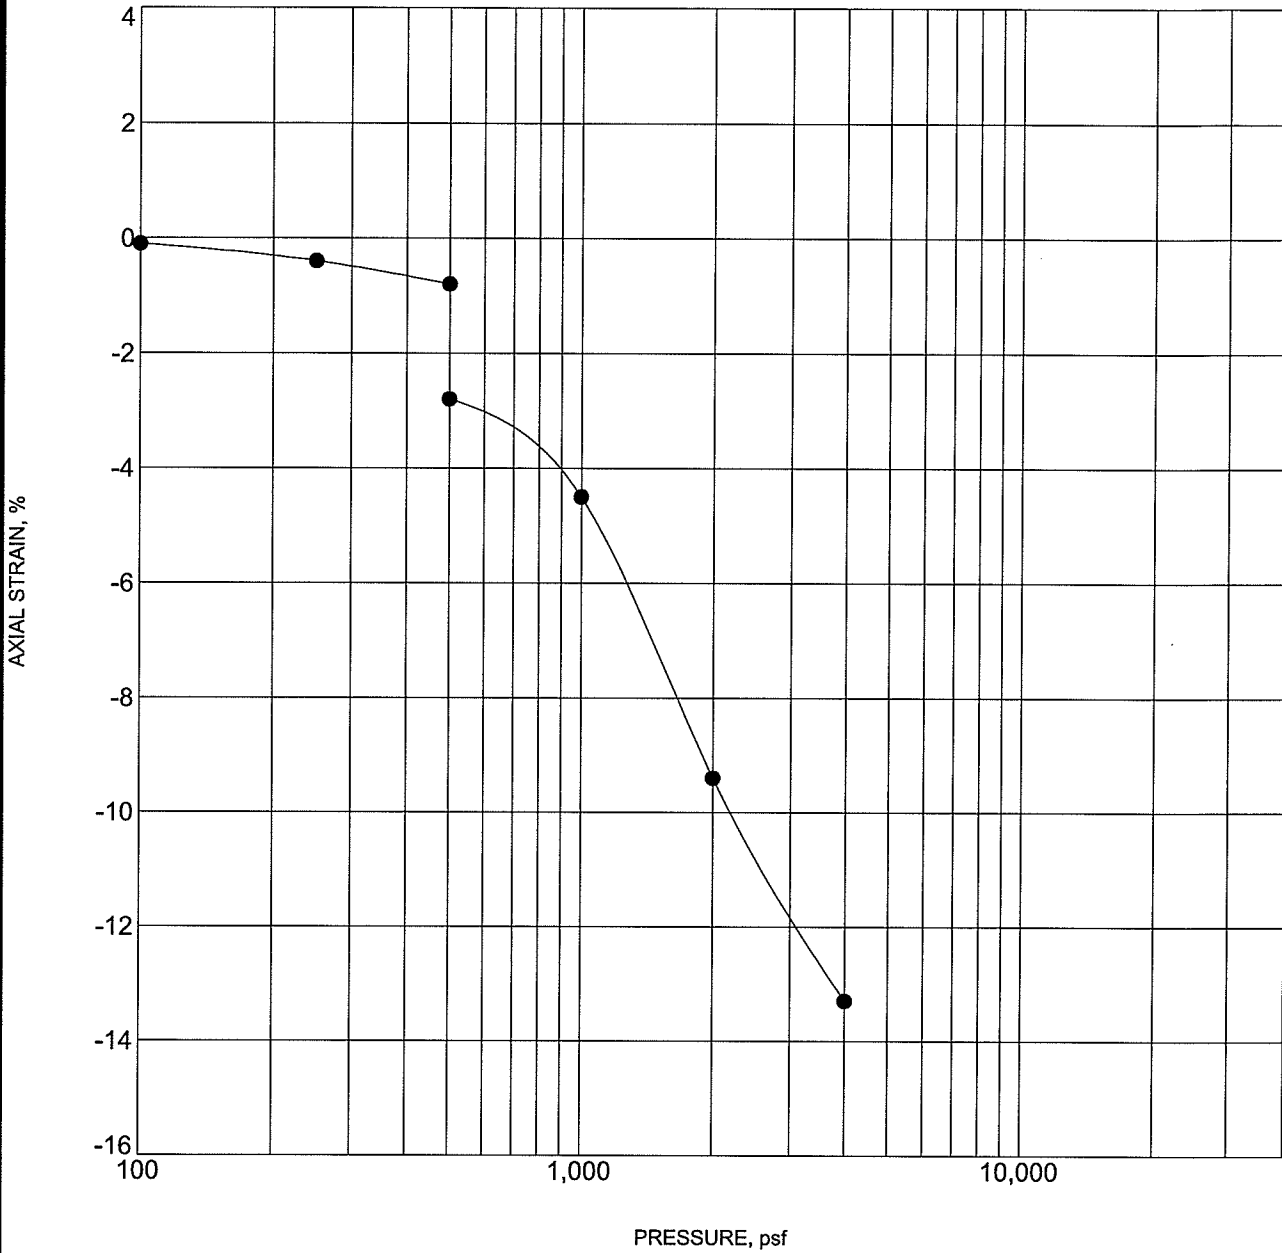
# SWELL CONSOLIDATION TEST

ASTM D4546

●	Specimen Identification	Classification	$\gamma_d$ , pcf	WC, %
	B-4      2 - 3 ft	FILL-CLAYEY SAND(SC)	102	6

NOTES: Sample inundated with water at 500 pounds per square foot (psf.)

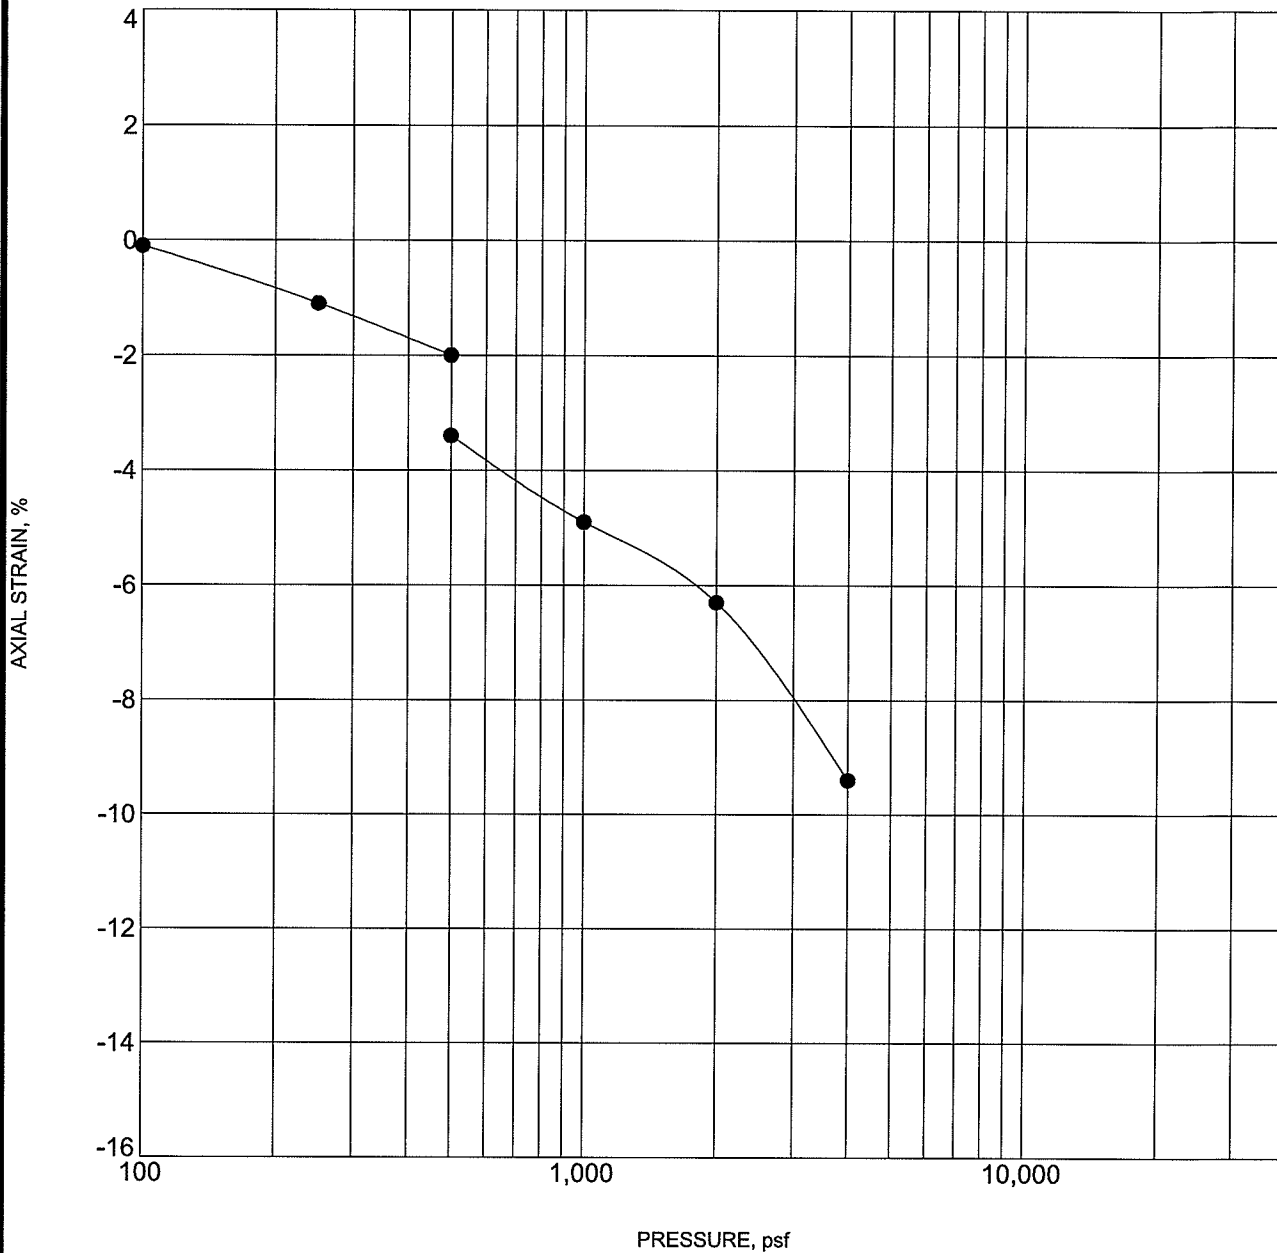
# SWELL CONSOLIDATION TEST

ASTM D4546

●	Specimen Identification	Classification	$\gamma_d$ , pcf	WC, %
	B-4 7 - 8 ft	WEATHERED CLAYEY SANDSTONE	99	9

NOTES: Sample inundated with water at 500 pounds per square foot (psf.)  
 Sample may have been disturbed during sampling or preparation for laboratory testing.
